# Manhole Inspection Summary

Manhole # S31II\_004MH

Insp Date: **4/6/07 2:07 PM**

**Location** Address: **1534 MCMECHEN ST**

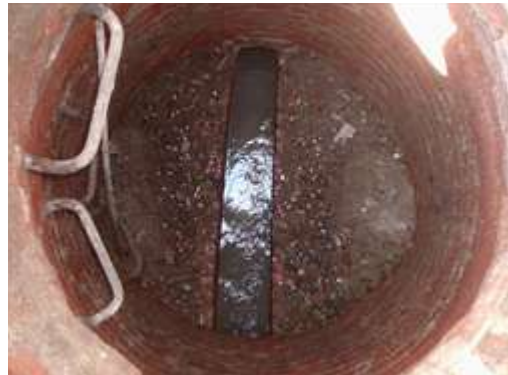
Top View

Corroded steps. Evidence of surcharge - Bench debris.

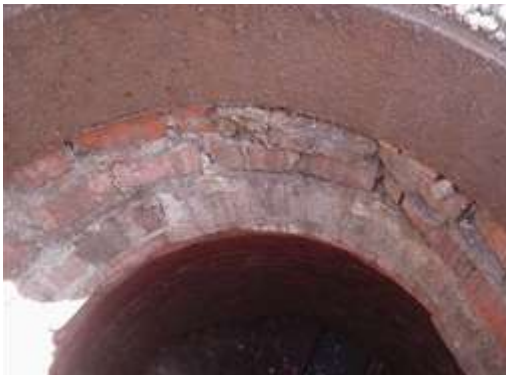
Defect

Frame leaks. Adjustment deterioration and infiltration. Corbel infiltration.

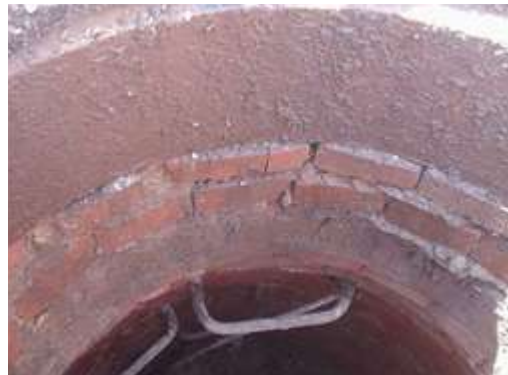
Defect

Frame leaks. Adjustment deterioration and infiltration. Corbel infiltration - other side.

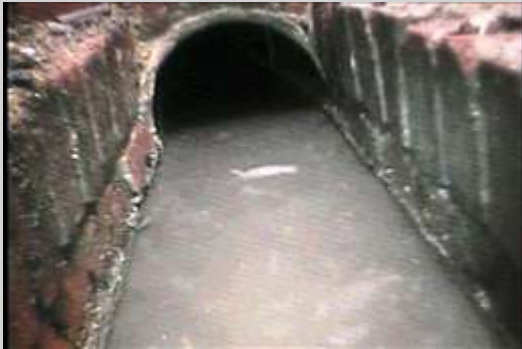
### 8 in. Circular Gravity Sewer Pipe Out @ 12 O'Clock

Deposits: ☐ None ☐ Mud ☐ Sludge ☐ Debris ☒ **Grease**

Silt Depth: **0** (in.) Deposits Extent: **Light**

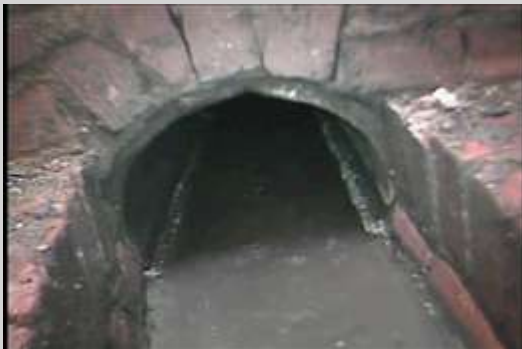
### 10 in. Circular Gravity Sewer Pipe In @ 6 O'Clock

Deposits: ☐ None ☐ Mud ☐ Sludge ☐ Debris ☒ **Grease**

Silt Depth: **0** (in.) Deposits Extent: **Light**

Infiltration: **Evidence** Pipe Seal Cond: **Unknown**
